# Spreewerk "cvq" Code Analysis

## From Jan Balcar:

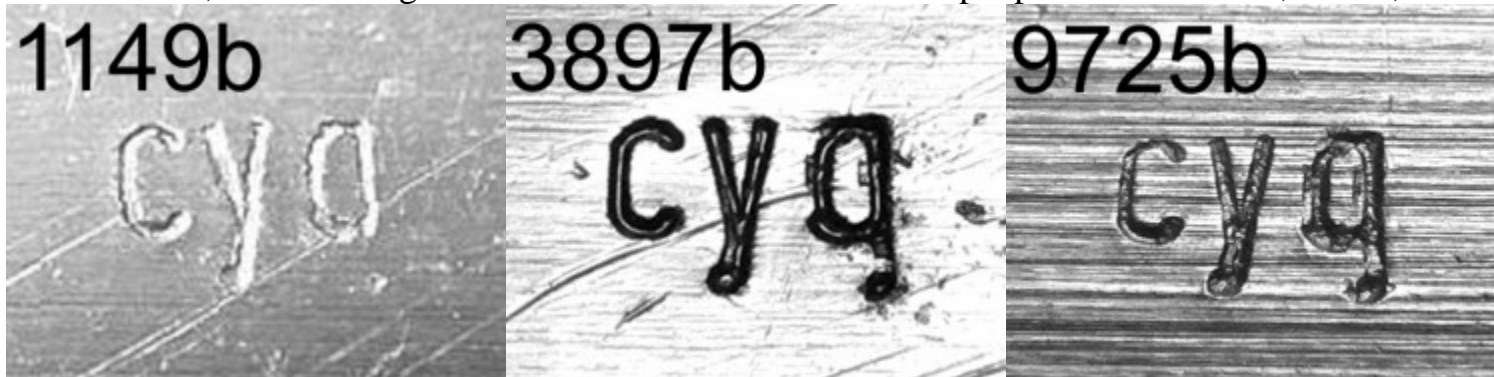
Early production pistols have the cyq code that is done with a pantograph machine. Dies were not used. The pantographic engraving machine is a device which is based on the principle of parallelogram, coupled with a rotating ball end milling cutter. The characteristic signs that a pantograph engraver has been used, are that the bottom of the engraved letters show the evidence of tool marks, and the margin of the letters are not raised. Example pistols are: 1149b, 3897b, and 9725b.

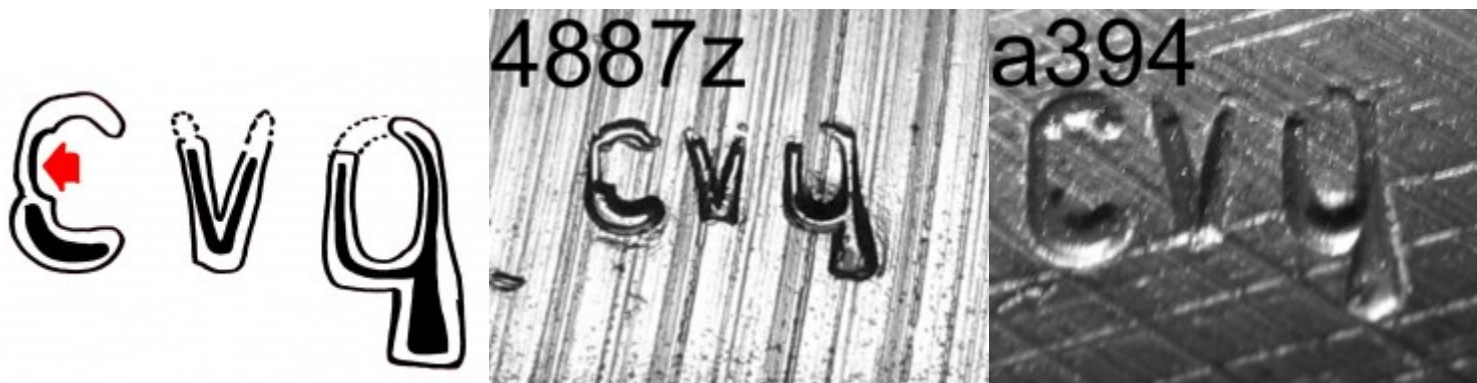
From the middle of the “z” suffix in the first alphabetical series there are some pistols marked with the cvq code. The same situation is present in the second pre-fixed alphabetical series as well as the zero series. You will see here 9 examples of the cvq code: 4887z, a394, a818, a1462, a5597, a8208, b3464, 05729, and 0066. All of these have the cvq code stamps that have the defect in the letter “c”, similar defects on the upper part of the letters “v” and “q”, and also the widened lower part of the letter “q”. This same die that produced this cvq code shows further wear as time goes on. The progression of SN’s now also shows that the lower part of the “q” is fading. The only exceptions are two pistols from zero series production. SN 05957 has the cvq marking done with the same die that has the defective letter “c”, and the marking seems to be done from an earlier time such as around the same time as SN 4887z. My explanation is that both pistols have mismatched barrels, and the frames are not numbered. Both of these pistols were stolen from the factory in the last days of the war.

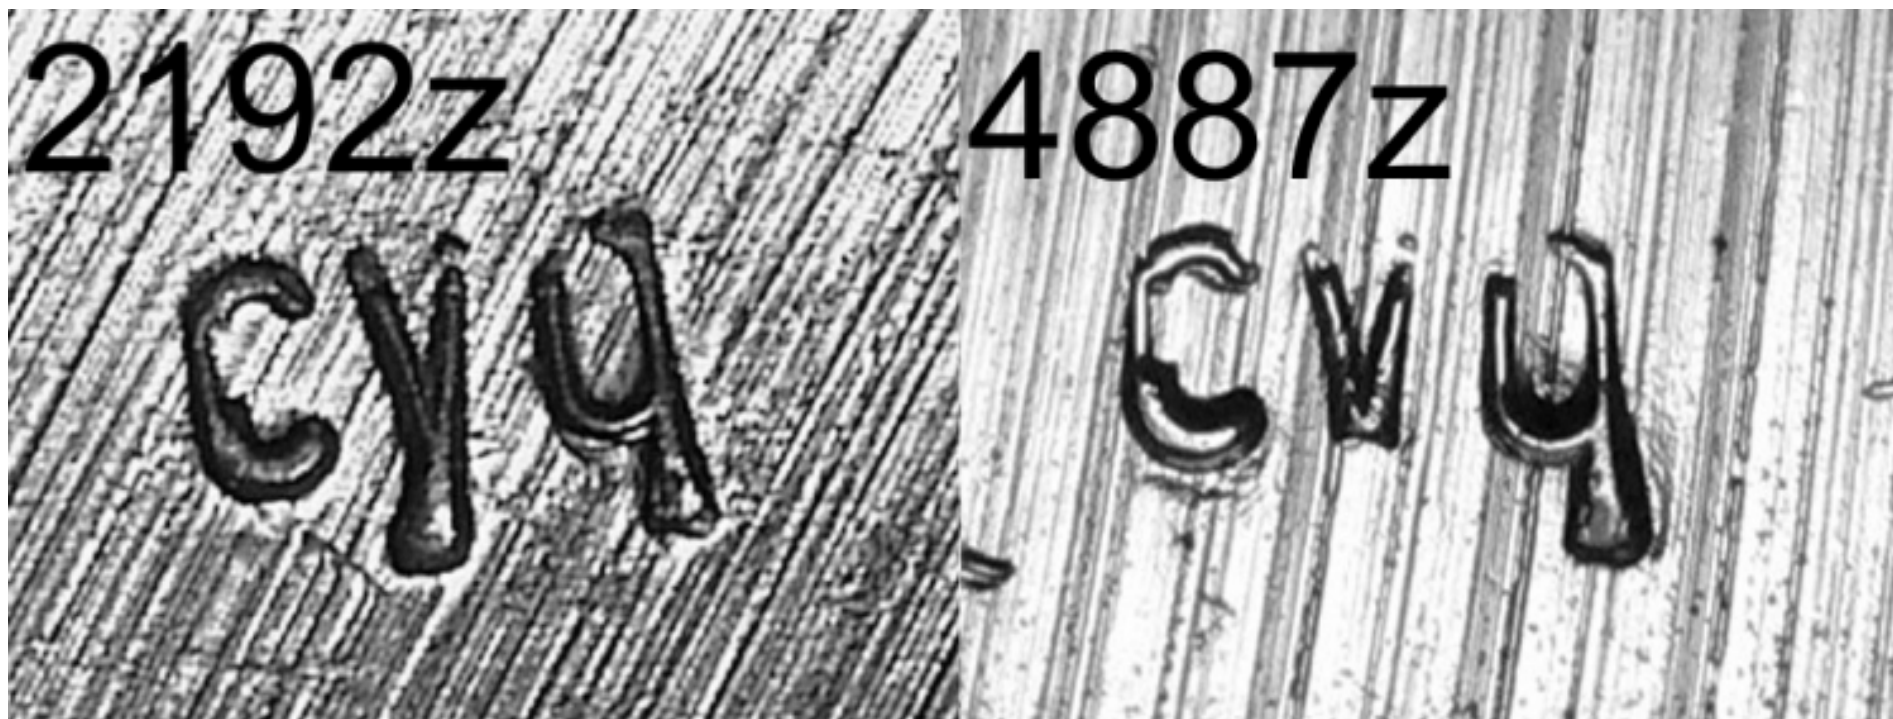
And now we have a smaller gap in-between these stamps.
